Reparação de Emergência do Quebra-Mar – Fase 1

Porto Militar – Praia da Vitória, Açores

Breakwater Emergency Repair – Phase 1

POL Pier – Praia da Vitória, Azores

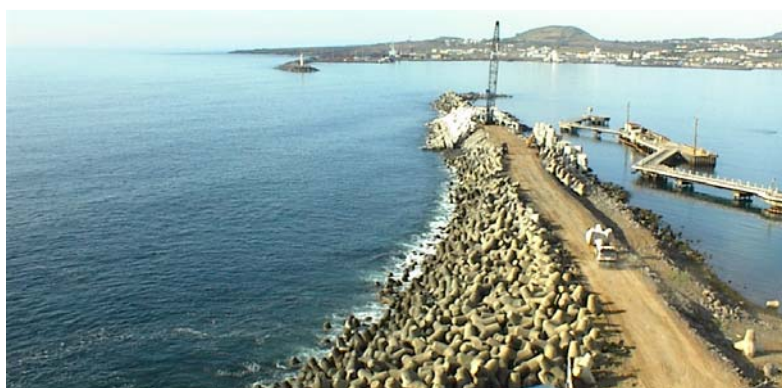
Topo: aspecto do local dos trabalhos
 Top: site, general view

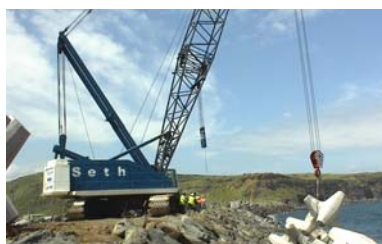
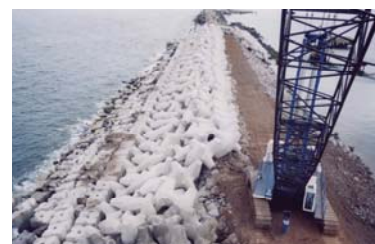
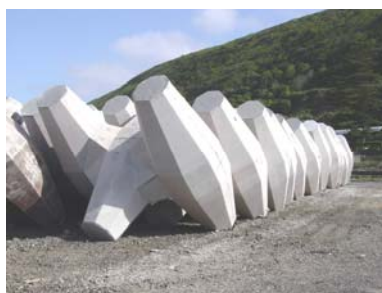
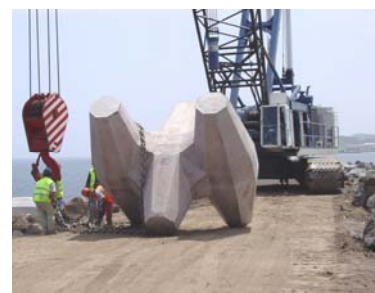
Imagens inferiores: CORE-LOC e antifers
 Lower images: CORE-LOC unit and antifers
